Status of the Photonics DP20-B527-18 laser at Caltech

Liyuan Zhang and Ren-Yuan Zhu

January 18, 2023 (Previous Reports: 1st: 6/21/22, 2nd: 10/4/22)

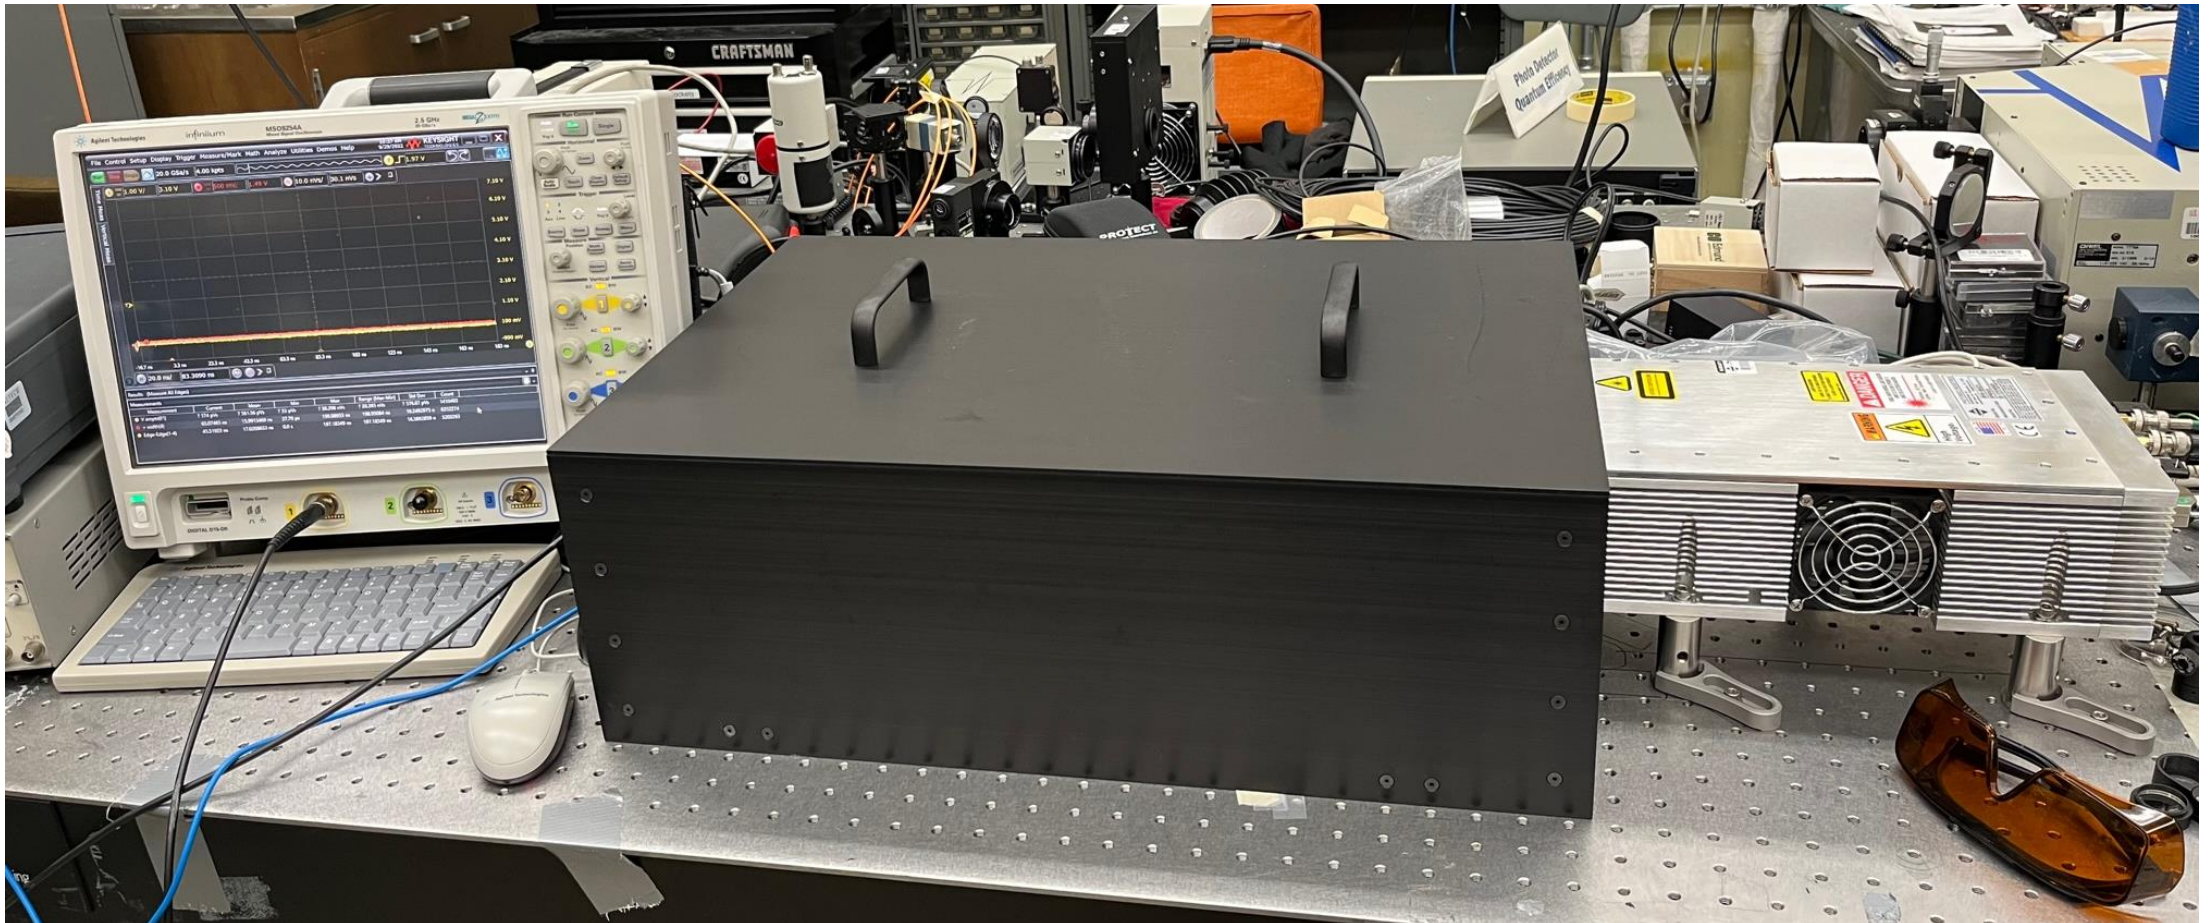
The 2nd Service at Photonics

The laser was sent back again to Photonics again from for the 2nd service 8/10/22 – 9/21/22
A cavity mirror in the laser head was found burned and was replaced by Photonics

- In the 2nd service (Aug. 10 – Sept. 21), Photonics engineers replaced a cavity mirror in the laser head. After the 2nd service, the laser meets all specification.

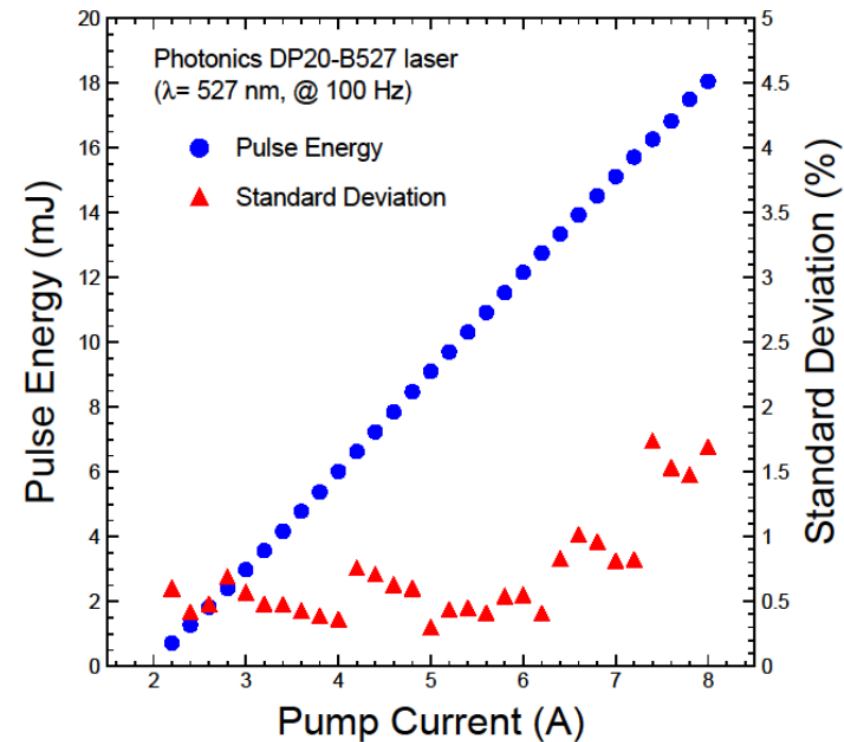
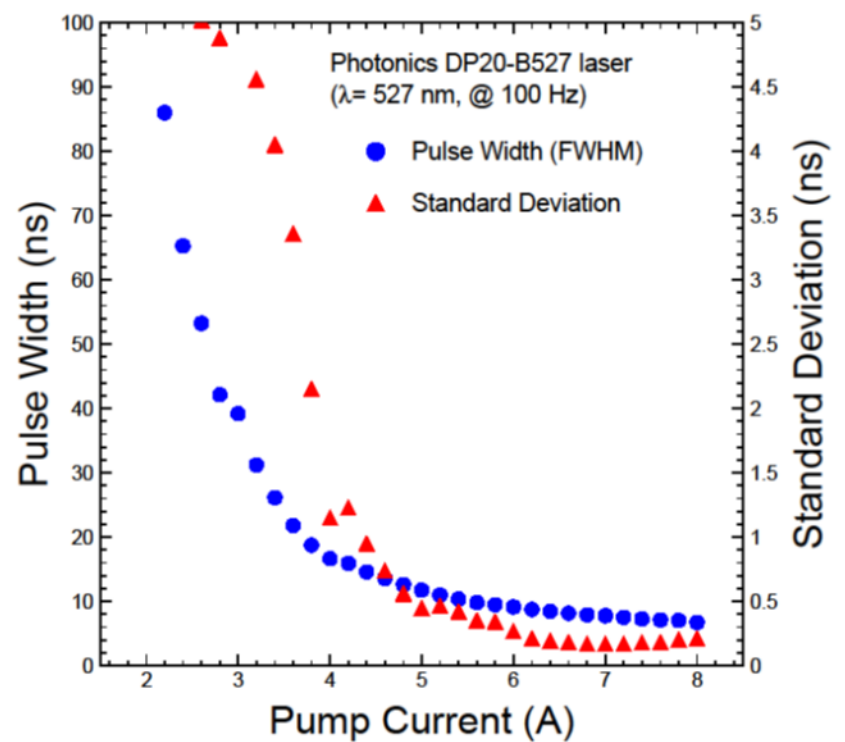
After the 2nd Service at Photonics

Laser meets CMS specification
Pulse energy reaches 18 mJ @ 8 A with rms < 2%
Pulse width < 10 ns @ > 5.0 A with rms < 0.5 ns
Pulse jitter < 0.5 ns @ > 3.5 A

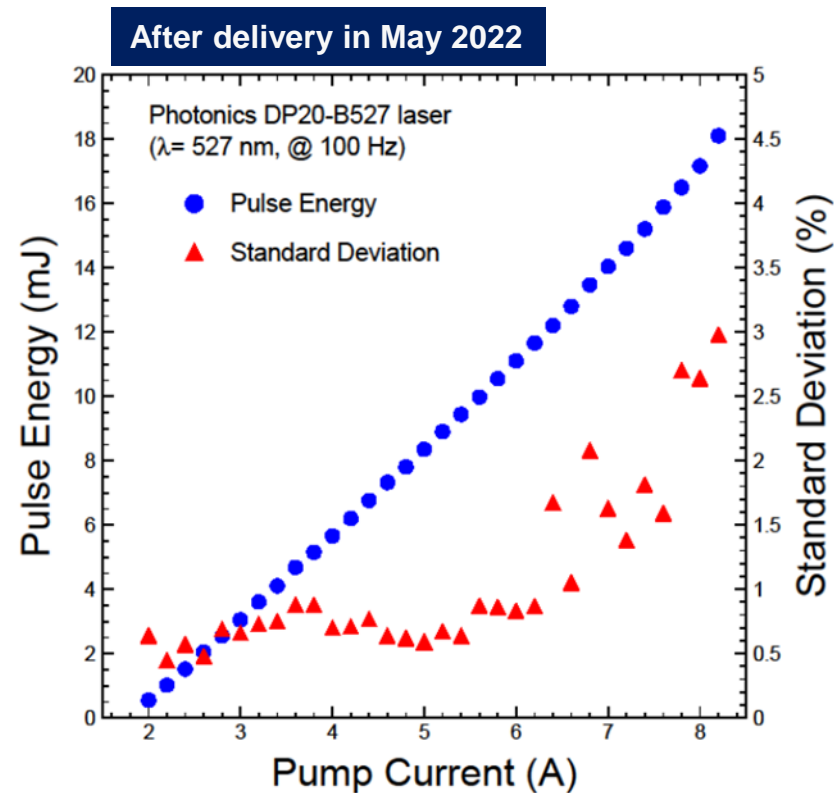
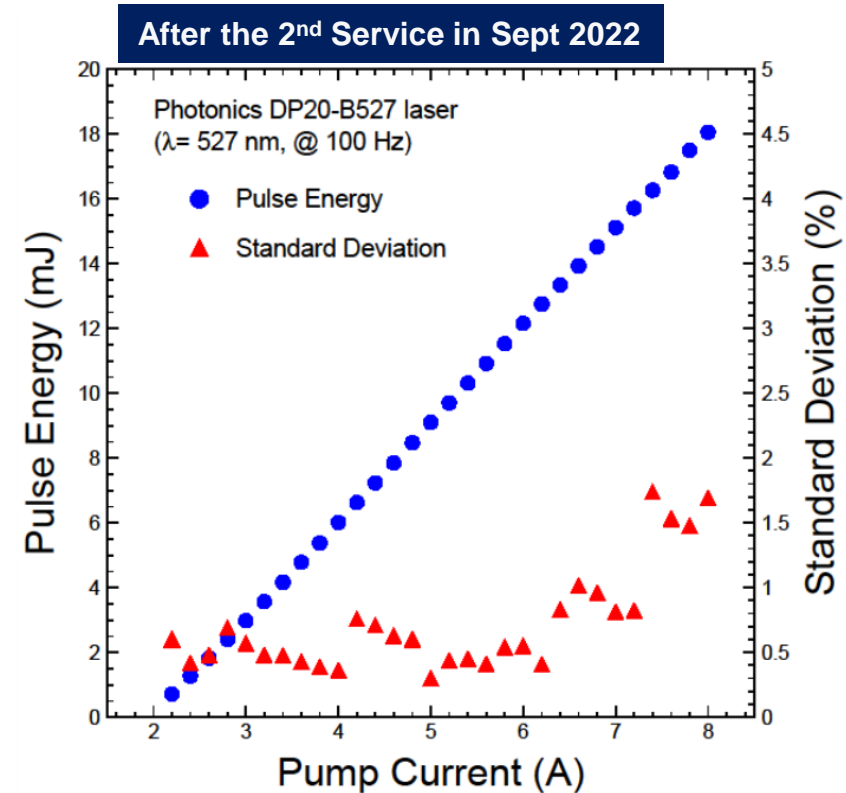
History: Laser Pulse Energy

Reached 18 mJ with rms of $< 3\%$ after the May delivery, but lost power at 16 mJ with rms $> 6\%$ after the 1st service. Reached 18 mJ with rms $< 2\%$ after the 2nd service.

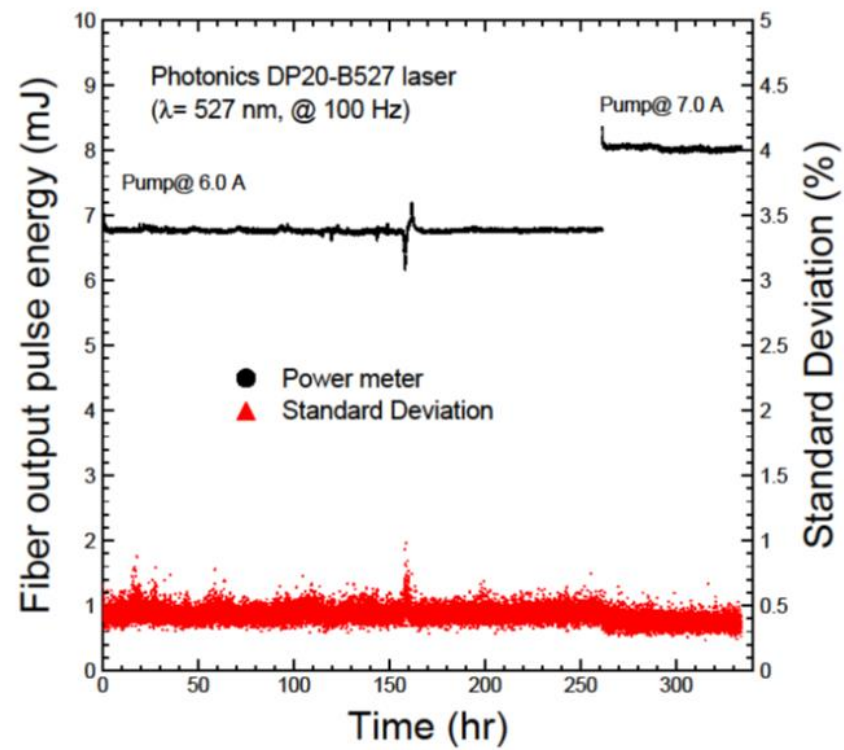
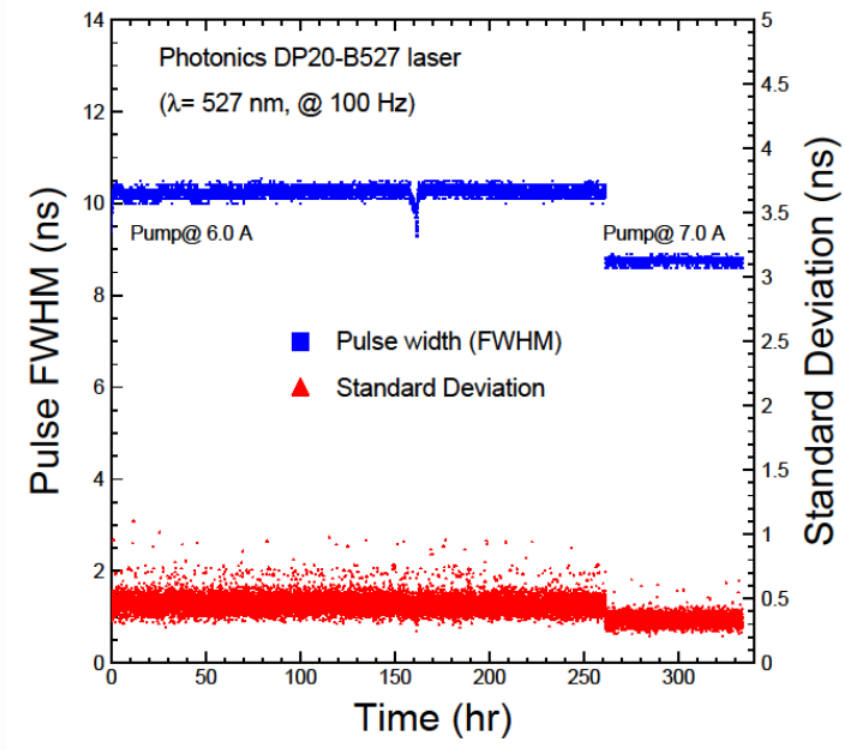
Result: Long-Term Stability Test

Stable operation with 6.0/7.0 A pumping current (6.8/8.0 mJ in fiber) for 11/3 days
The dip at ~160 hrs was caused by a campus-wide power interruption
A slight degradation observed after the pump current increased to 7.0 A
The quartz fiber output end burned at 8 A, indicating a damage threshold of 8-10 mJ

- **The fiber output end was burned at 8.0 A, indicating a damage threshold of 8-10 mJ, which is consistent with the OFS statement.**
- An FC connector damage test shows a lower damage threshold of ~4 mJ, indicating that the most vulnerable part of the ECAL monitoring system is the input FC connector in the 5 x 1 optical switch.

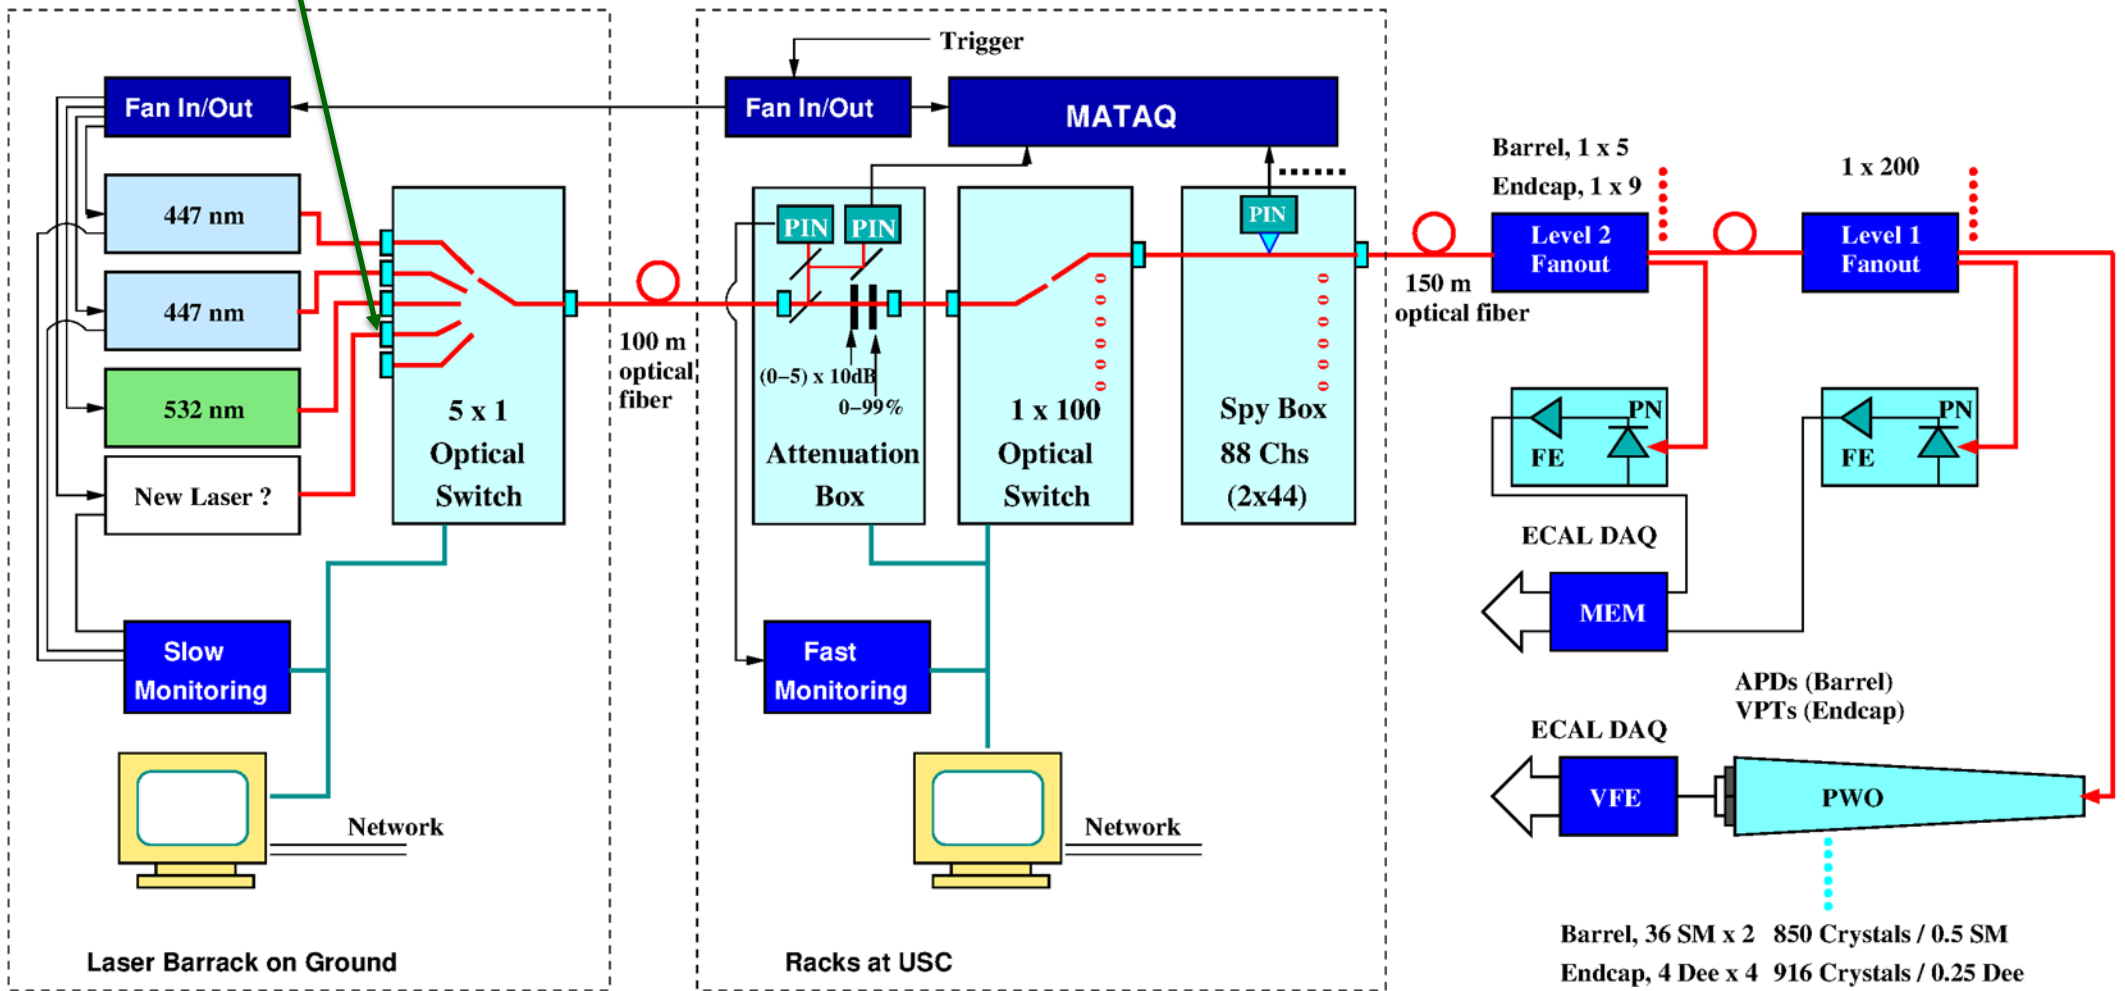
The Most Vulnerable Part

The input FC connector in the 5 x 1 optical switch is the most vulnerable part
 18 mJ will certainly damage the FC connector in the 5 x 1 switch

- Additional works are needed to increase the damage threshold for the FC connectors. Approaches in plan are using thermal resistant epoxy or FC connectors without epoxy.

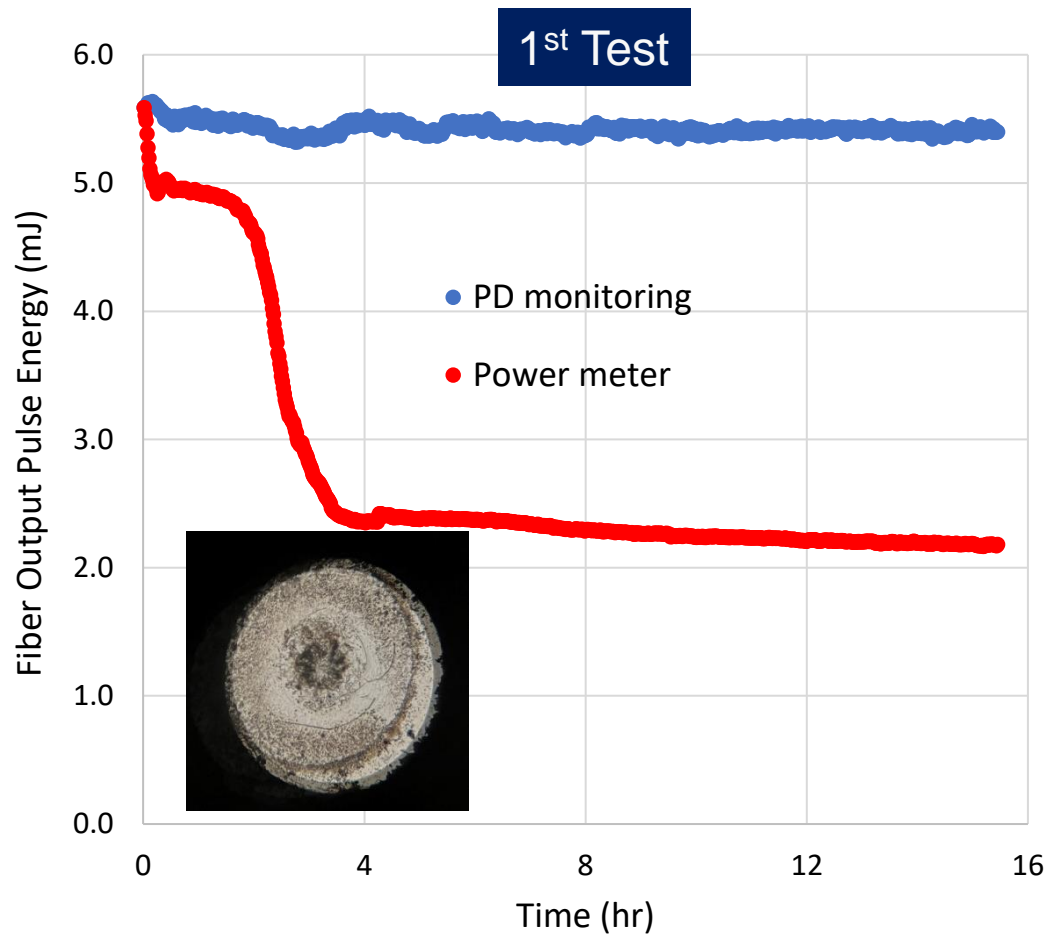
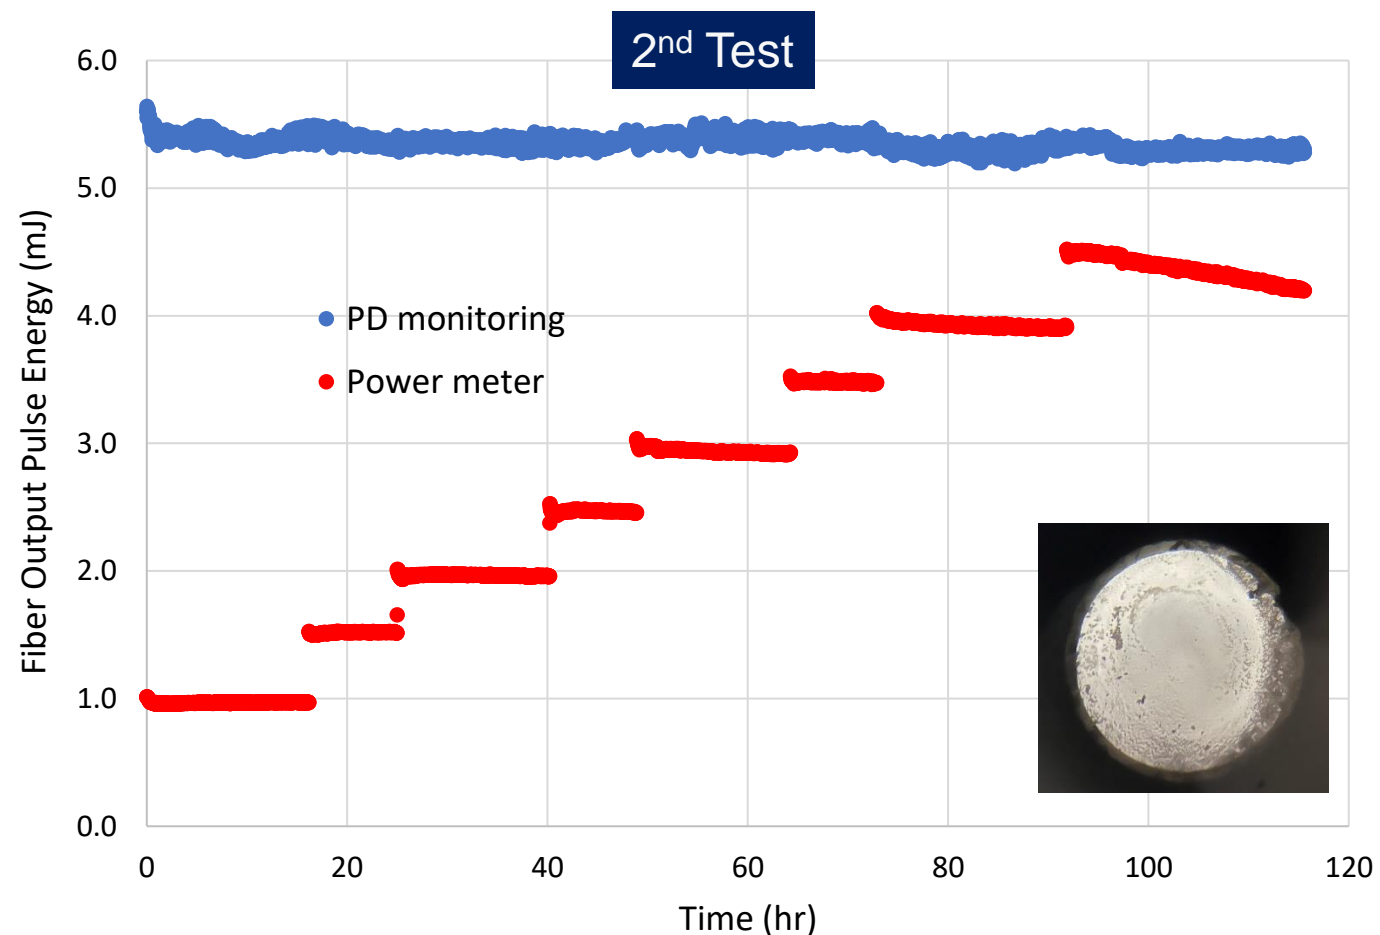
Result: FC Connector Damage Test

The 1st test at 6.0 A (~8.5 mJ at the FC connector) led to power losses due to a black contamination in the FC connector, which was attributed to epoxy evaporation. In the 2nd test an attenuator was used to reduce input power for FC. The fiber output pulse energy was increased from 1 mJ with a 0.5 mJ step. Significant damage observed starting from 4 mJ output power.

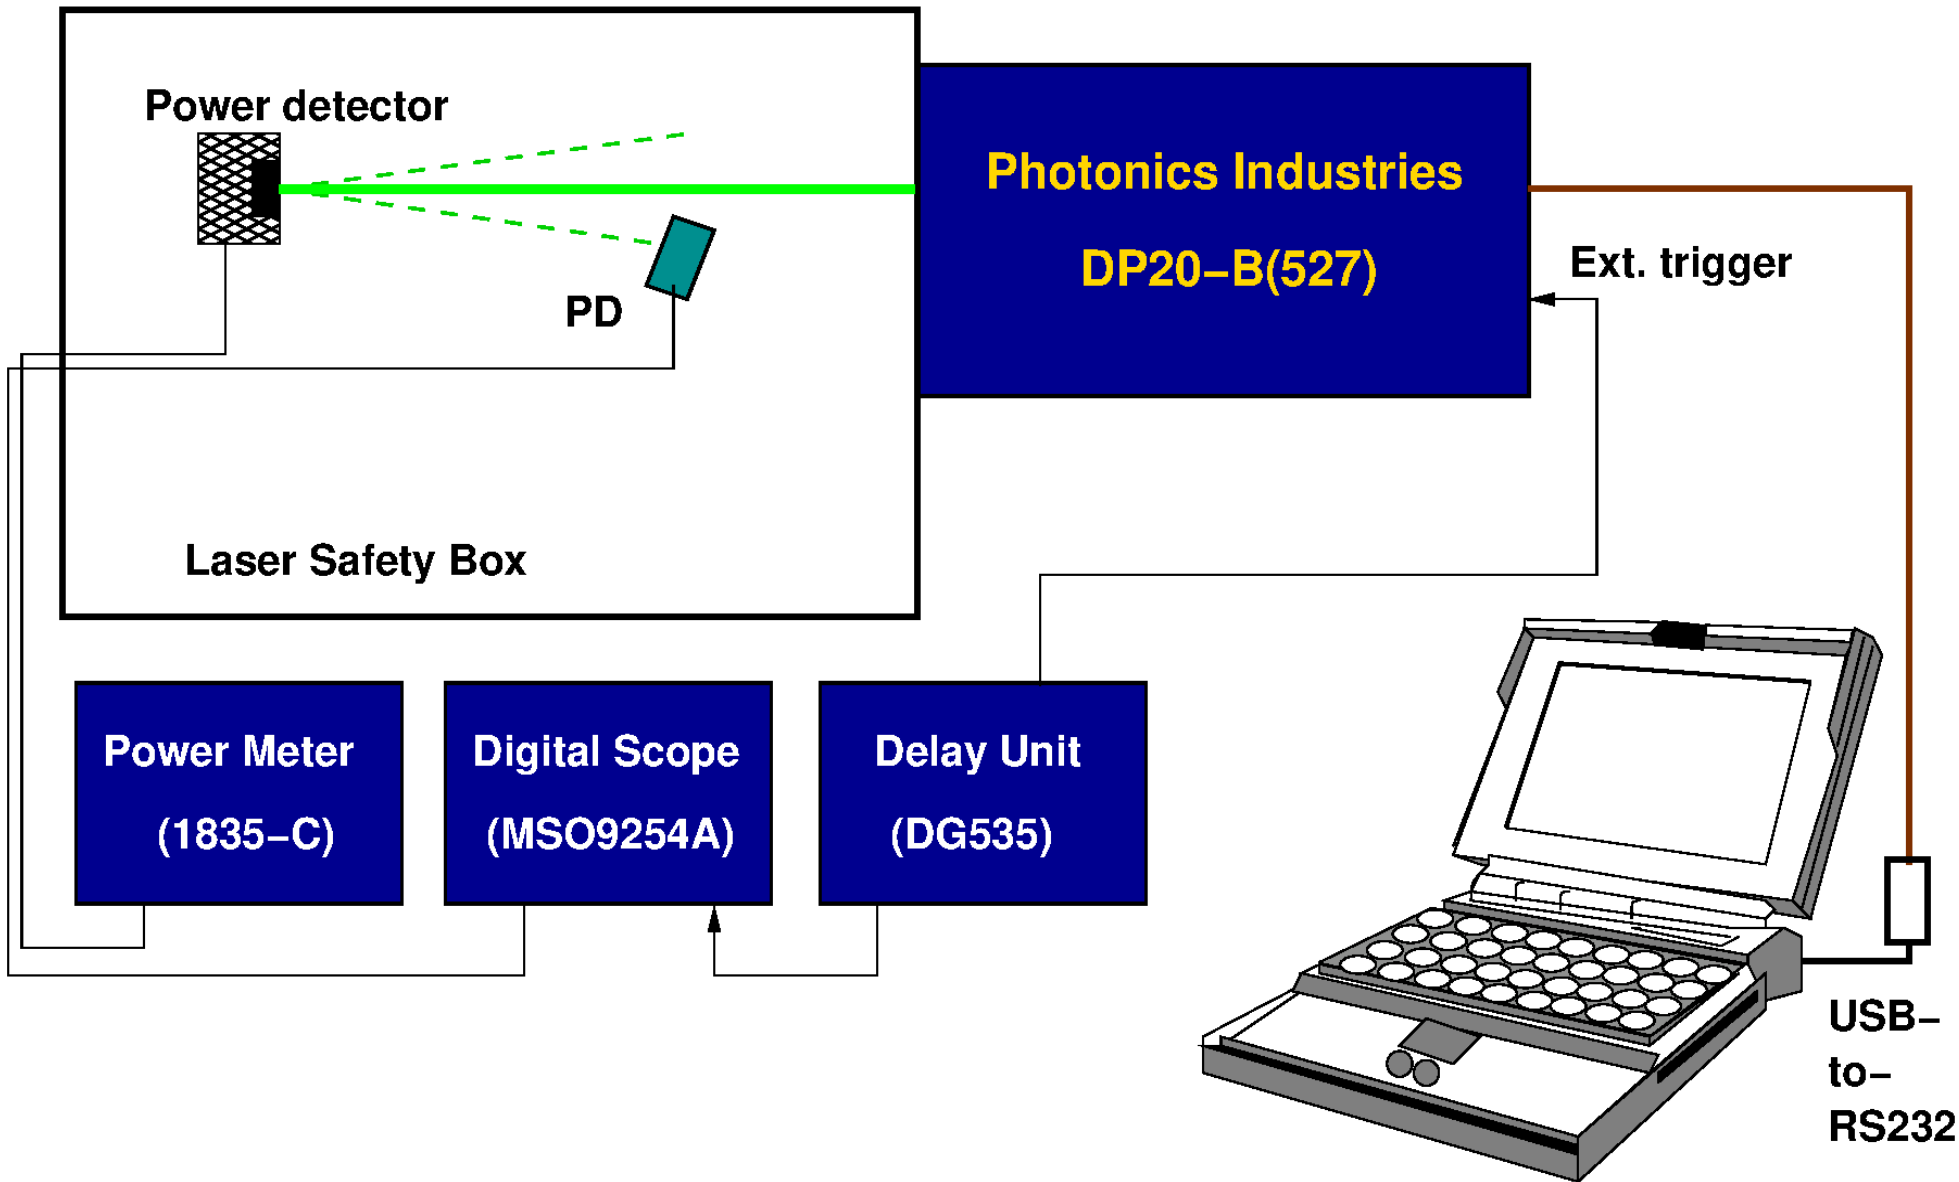
The Measurement Setup

Laser pulse energy calculated by using average power measured by a Newport power meter

Stability of laser pulse energy, width, center timing (jitter) measured by using a digital scope (MSO9254A) and a fast photodetector

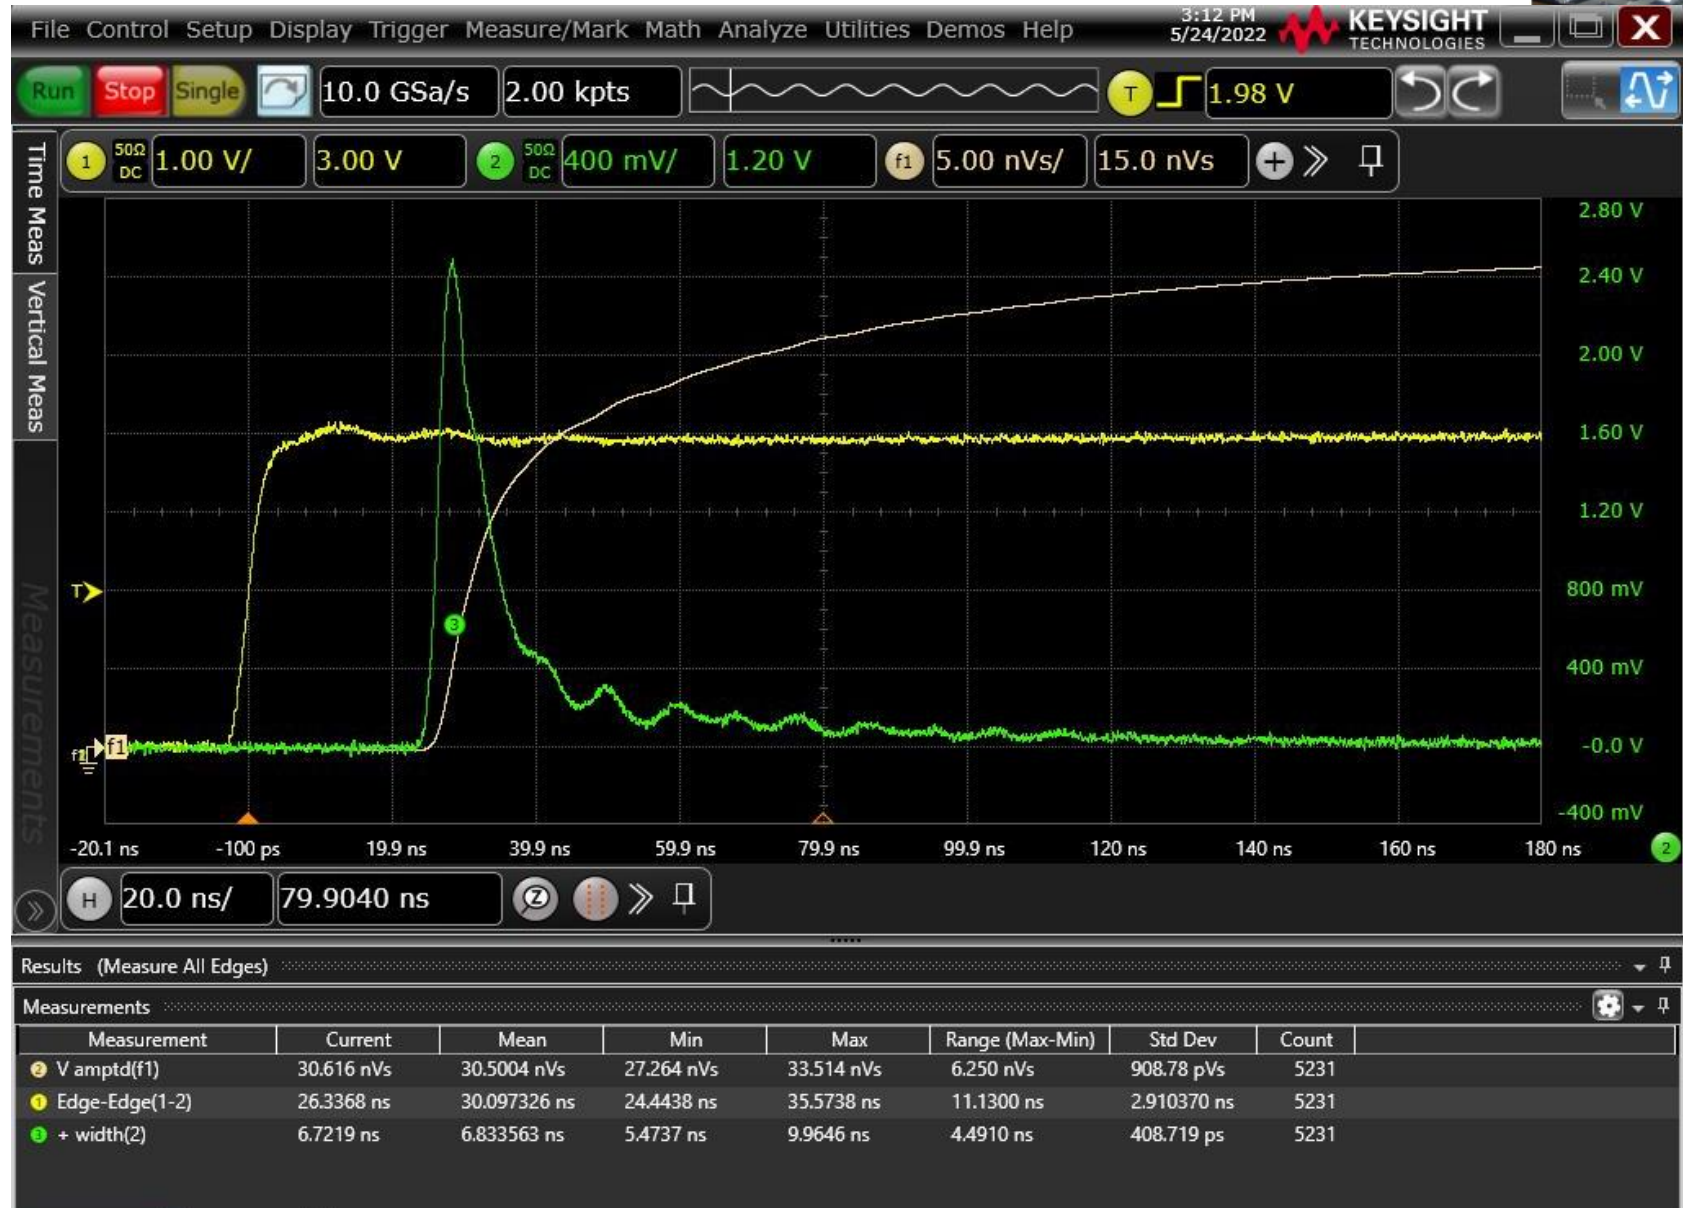
Trigger, Laser Pulse and Integration

MSO9254A and a fast photodetector used to measure:

- rms of pulse energy
- pulse width & rms
- pulse delay & rms (jitter)

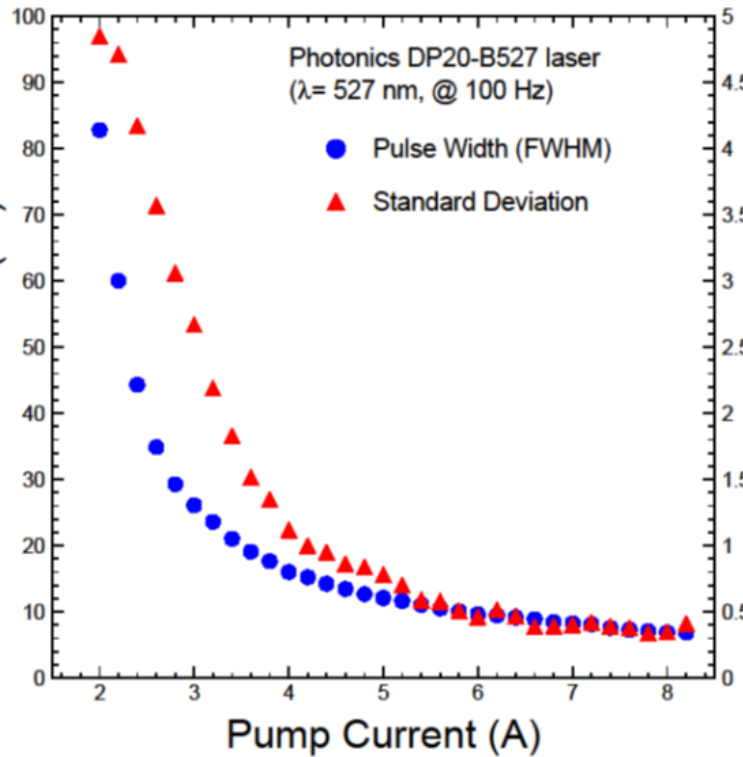
Laser Pulse Energy, Width and Jitter

Pulse energy meets the 18 mJ spec at >8A with rms of 3%, which agrees with Photonics brochure
Pulse width meets the 7 ns spec at >7.5 A with an excellent stability of 0.4 ns rms
Pulse jitter is about 3 ns, larger than the 1~2 ns spec. Work with Photonics engineer is on-going.

A delay of 600 μs+ from external trigger required to pump diode

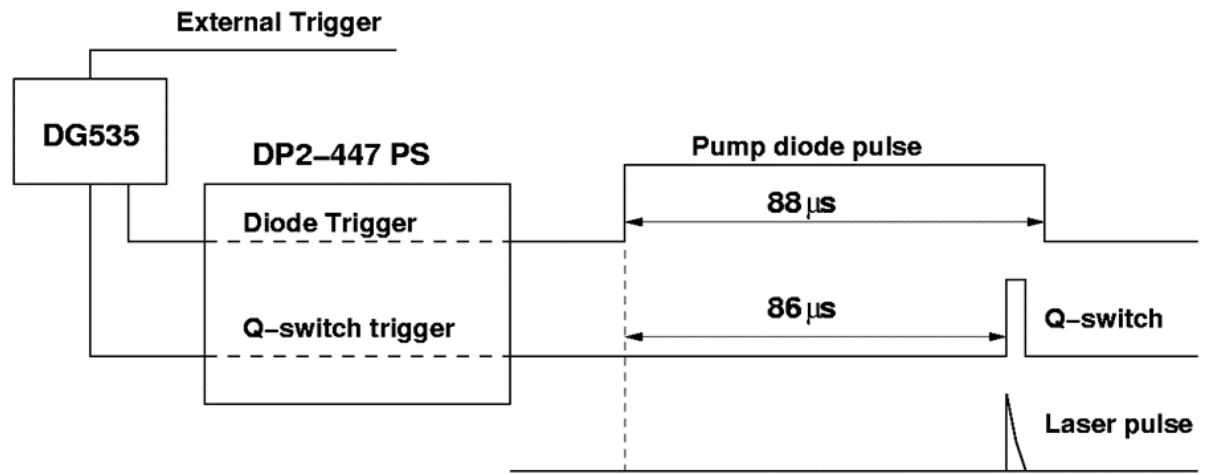
The Plan for Pulse Jitter Improvement

Revise the internal FPGA to introduce a Q-switch trigger similar to DP2, aiming at reducing the jitter to ~ 1 ns and the delay to < 200 ns

DP20-527 External Triggers

DP2-447 External Triggers

EXT FREQ : Each rising edge of an EXT FREQ TTL input triggers a laser output pulse. Any signal that generates a response in the laser controller is marked with an arrow.

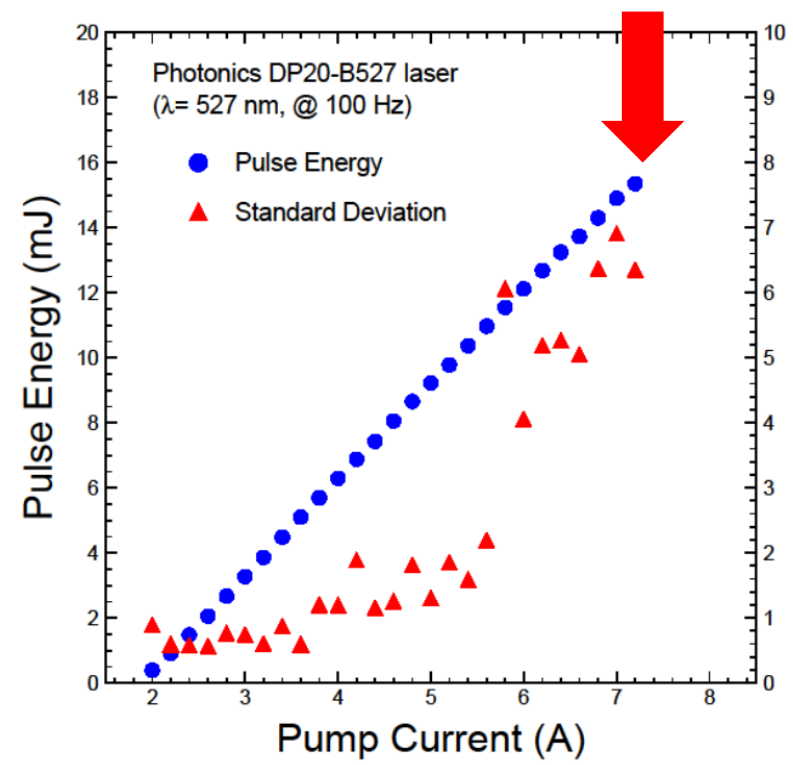
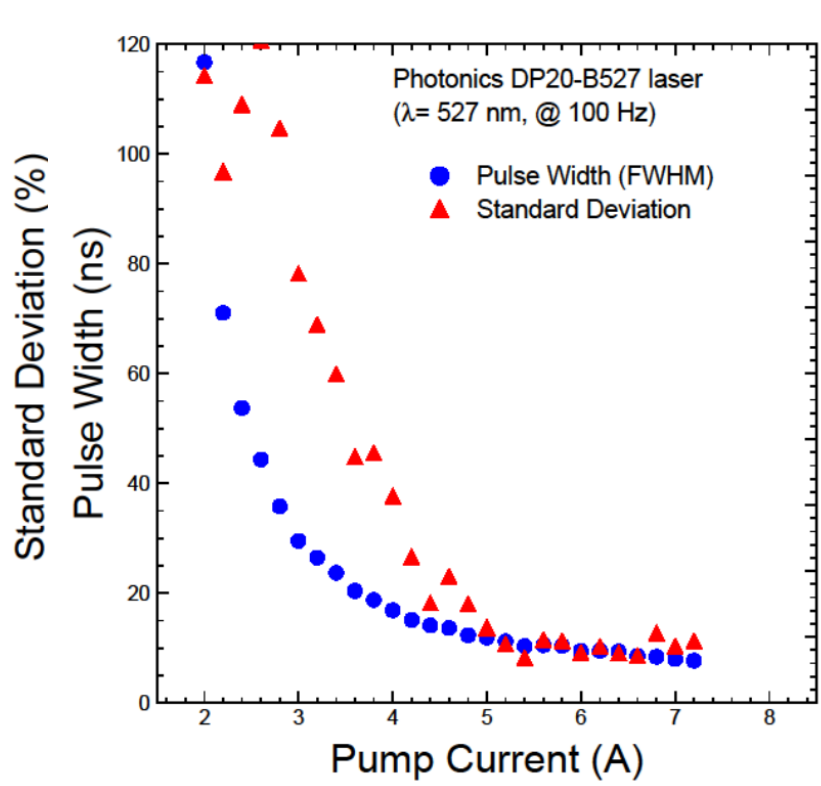
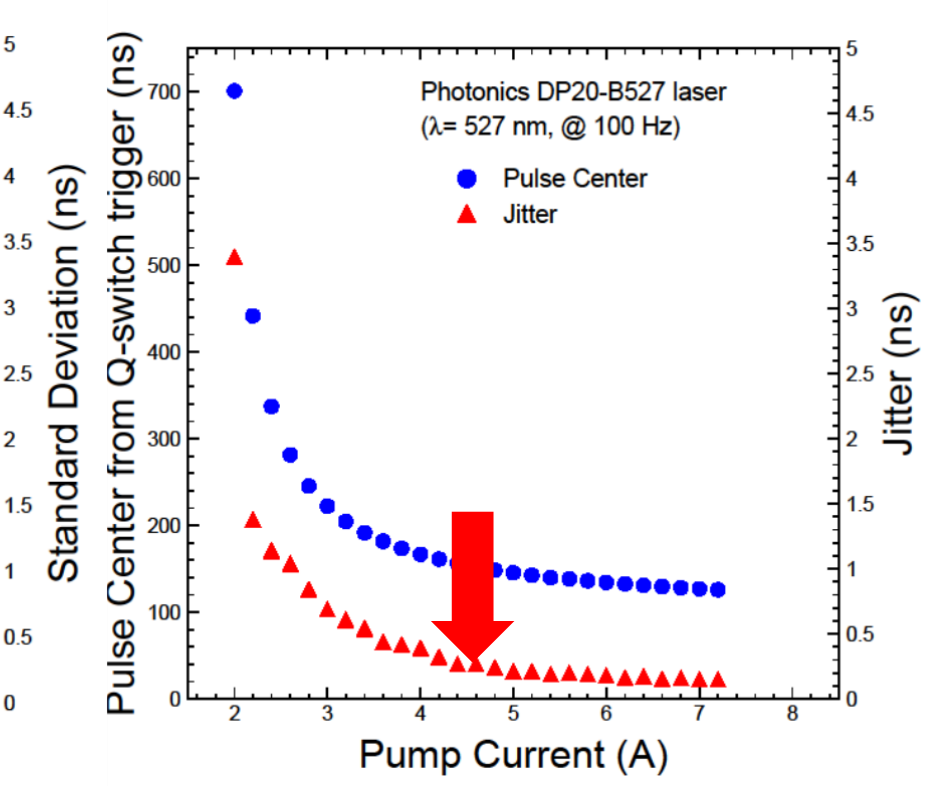
After the 1st Service at Photonics

The laser was sent back to Photonics from June 21 – July 27, 2022, when the FPGA firmware was revised and two external triggers were introduced for pump diode and Q-switch respectively. The pulse jitter was reduced to 1~2 ns, meeting spec. A large pulse energy deviation and a large power drop by ~90% was observed, indicating a burned optic in the laser head.

- In the 1st service (Jun. 21 – Jul. 27) Photonics engineers reprogrammed the internal FPGA and introduced an additional external trigger for the Q-switch. After the 1st service the jitter and the delay from Q-switch trigger were reduced to < 0.5 and 200 ns respectively at > 4 A (10 mJ). The laser, however, lost power during the investigation.
